Key West, FL, United States

Keys Energy Services Fuel Storage Tanks

Area Coated: Tank Exterior

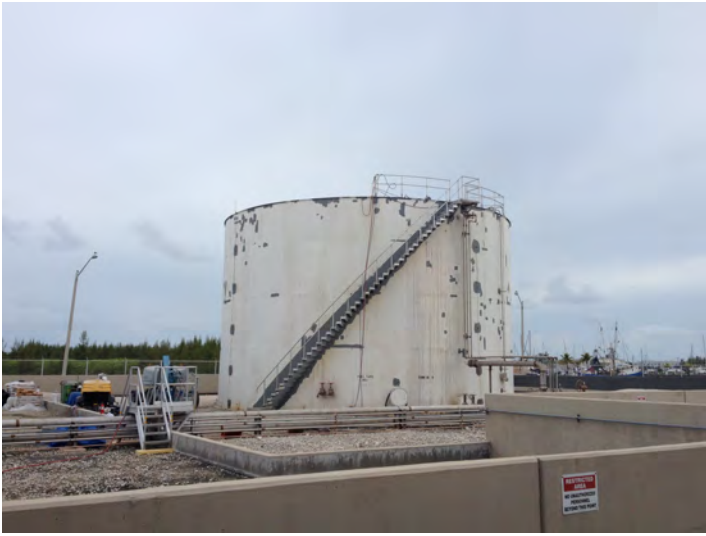
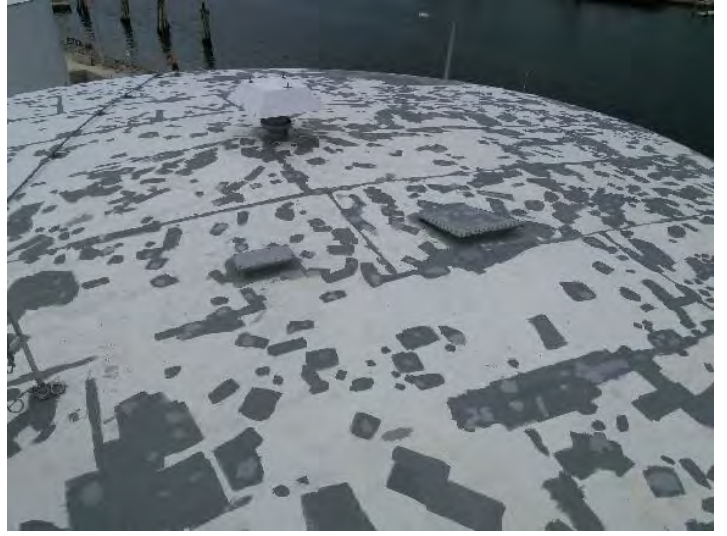
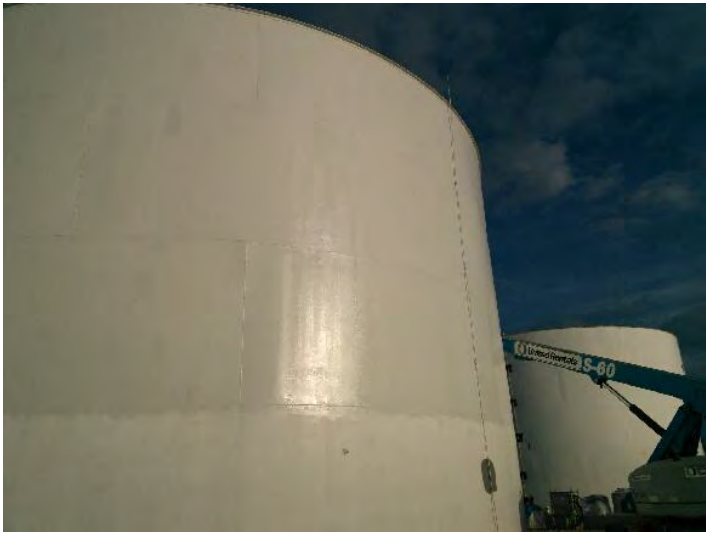
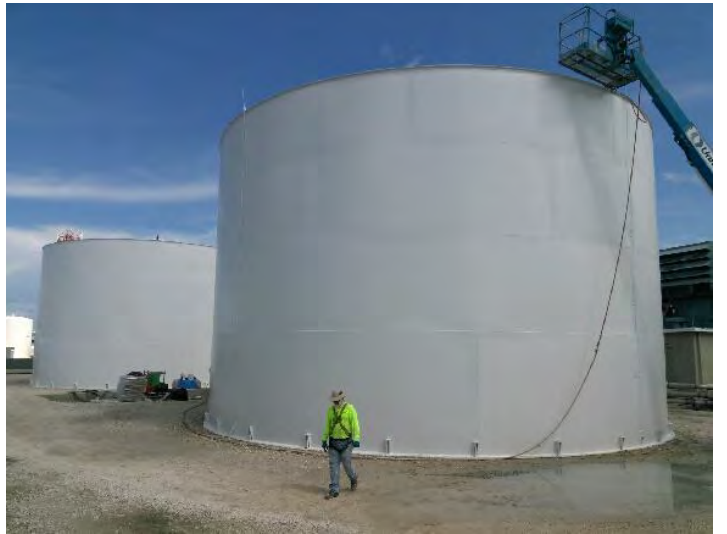
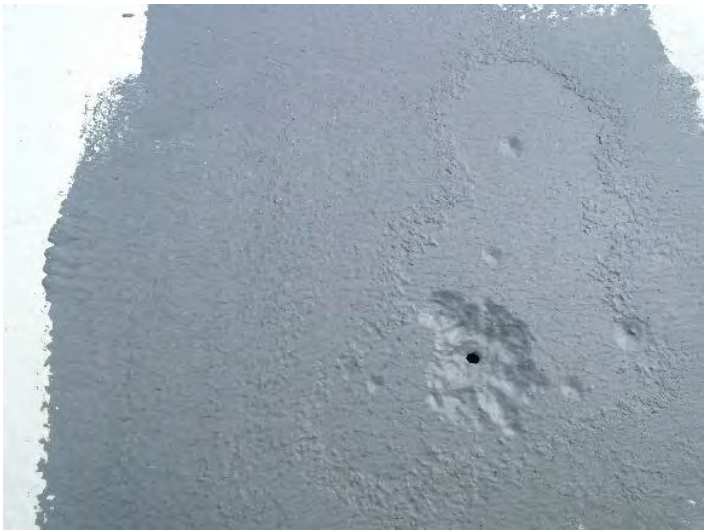
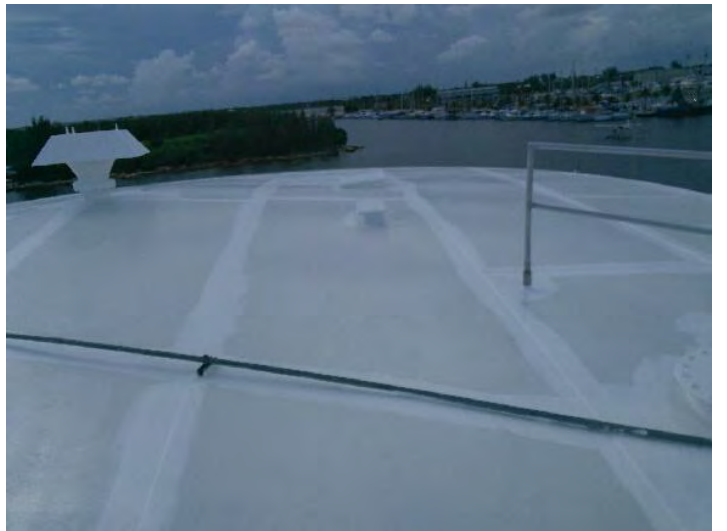
Florida Municipal Power Agency had to make modifications and repairs to two Fuel Oil Storage Tanks located at their Stock Island, FL facility. Based on the condition of the existing coating it was determined the tanks were a solid candidate for an overcoat system with spot blasting of rusted areas and areas where repairs were made. Due to the fact the tanks were in service at the time of painting, the contractor chose to use wet abrasive blast equipment to perform surface preparation on the tank in order to minimize spark potential of the blast media.

During the course of surface preparation some spots on the roof of the tank were uncovered exposing small penetrations through the roof of the tank. Carboguard 501 was used in conjunction with fiberglass mesh to repair these areas prior to application of the intermediate and finish coats.

Carbomastic 90 was selected for use as spot primer on bare metal areas for ability to bond tenaciously to rust bloomed steel.

Carboguard 501 was used as a filler coat with fiberglass mesh to repair small holes in the roof of the tank.

Carboguard 890 was used as the intermediate coat to provide additional barrier protection to the steel substrate.

Carbothane 133LH was chosen to provide long-term color protection with a low sheen finish.
